CERTIFICATE OF CONFORMITY
No. 1211-CPD-AB0011
8460-02 RADIUS STRIKE

REHANDING THE DEADLATCH

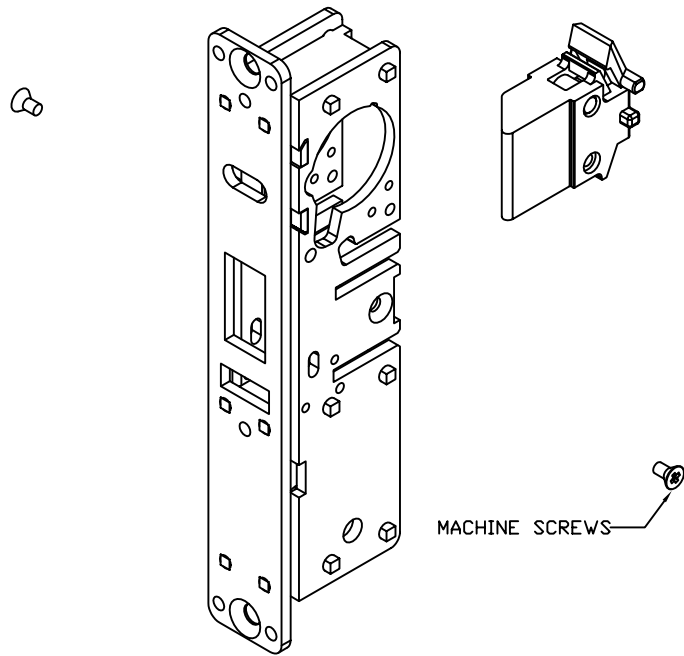
REMOVE THE TWO MACHINE SCREWS LOCATED AT THE REAR OF THE CASE AND REMOVE THE RETAINING PLATE.

REMOVE THE DEADLATCH AND AUXILIARY BOLT SPRINGS.

DISENGAGE THE DEADLATCH HEEL FROM FROM ITS SLOT AND PUSH THE LATCH ASSEMBLY ALONG ITS RUNNERS AND OUT OF THE CASE.

DEADLATCH SPRING

RETAINING PLATE

AUXILIARY BOLT SPRING

AUXILIARY BOLT

LATCHBOLT ASSEMBLY

HEEL

TURN THE LATCHBOLT ASSEMBLY SO THAT THE LATCH IS FACING DOWN.

REMOVE HEEL PIVOT PIN FROM THE LATCHBOLT ASSEMBLY AND CAREFULLY REMOVE THE HEEL.

WATCH OUT FOR THE SMALL DEADLATCH SPRING THAT IS LOCATED BENEATH THE HEEL AND MAKE SURE IT IS SITTING VERTICALLY.

TURN THE LATCHBOLT THROUGH 180 DEGREES TO THE OPPOSITE HAND AND INSERT THE HEEL INTO POSITION.

INSERT THE HEEL PIVOT PIN INTO POSITION AND CHECK THE DEADLATCH SPRING IS CORRECTLY LOCATED.

REINSERT THE LATCHBOLT ASSEMBLY INTO THE CASE RELOCATING THE AUXILIARY BOLT AND THE APPROPRIATE SPRINGS.

REFIT THE RETAINING PLATE AND SECURELY FASTEN WITH THE MACHINE SCREWS.

CHECK THE OPERATION OF THE LATCHBOLT ASSEMBLY AND THE DEADLATCHING FACILITY BY DEPRESSING THE AUXILIARY BOLT AND PUSHING THE LATCH. THE LATCH SHOULD NOT MOVE, IF IT DOES THE DEADLATCH SPRING IS NOT LOCATED PROPERLY; REMOVE THE LATCHBOLT ASSEMBLY AND REPOSITION.
